TOWN OF VAIL FLOOD DAMAGE REPAIR PLAN

Stephen's Park bank stabilization and access

Location: Gore Creek | Vail, Colorado
Project Duration: Ongoing Multiple Project Implementation
Project Budget: \$112K Project Development | \$584K Construction
Client: Town of Vail, Colorado
Contact: Tom Kassmel | Town Engineer | 970-479-2235 | TKassmel@vailgov.com
Contractor: Colorado River Works | Ted Seipel | 970-471-0233 | ted.seipelco@mac.com

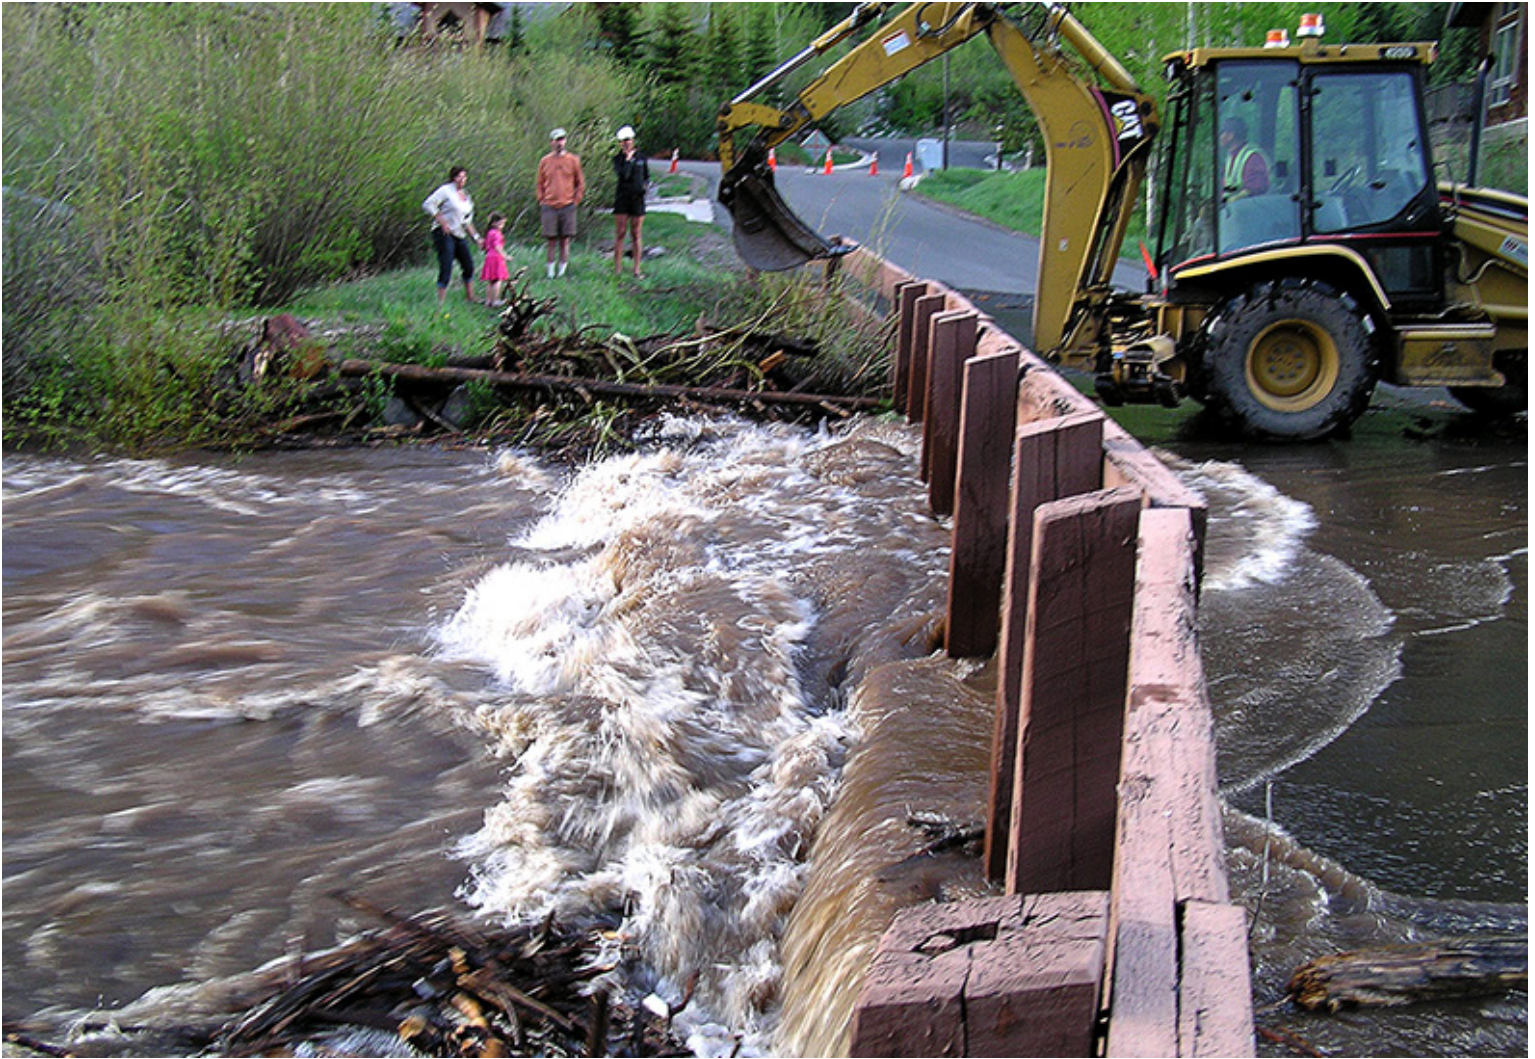
Sixty feet of flood erosion at this river bank threatened collapse of 150 foot tall conifer trees and the capture of historic channels pictured here. RiverRestoration stabilized the eroding bank with a combination of stone terracing and dense riparian vegetation. The main channel was trained with a number of rock barbs. The toe of the banks supporting the conifers was stabilized with stone toe protection and significant revegetation of the understory. The project fronts the Stephen's Park dog park and is now the best place to cool off in Vail.

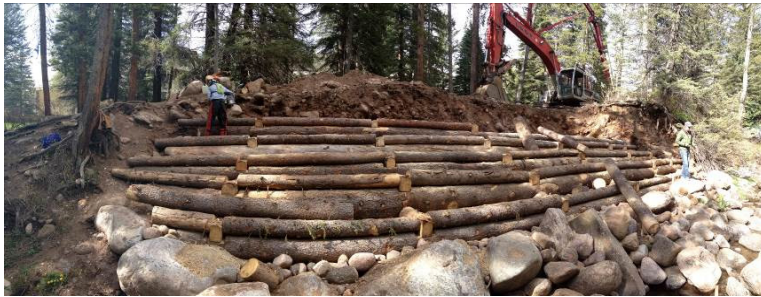
Bio-stabilization of a live crib bank with native riparian species designed by RiverRestoration was built to stabilize an actively eroding bank and provide safe access to a previously hazardous yet popular overlook of Gore Creek.

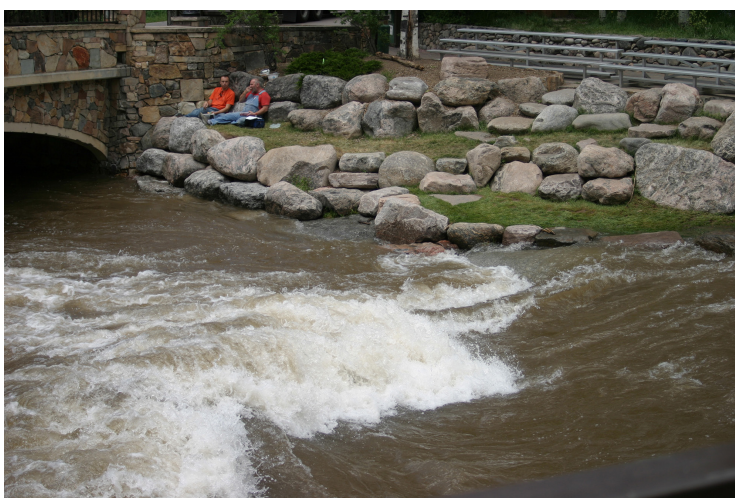
This photo was taken just after 100-year flood waters receded showing the RiverRestoration designed bank and whitewater feature in solid working condition

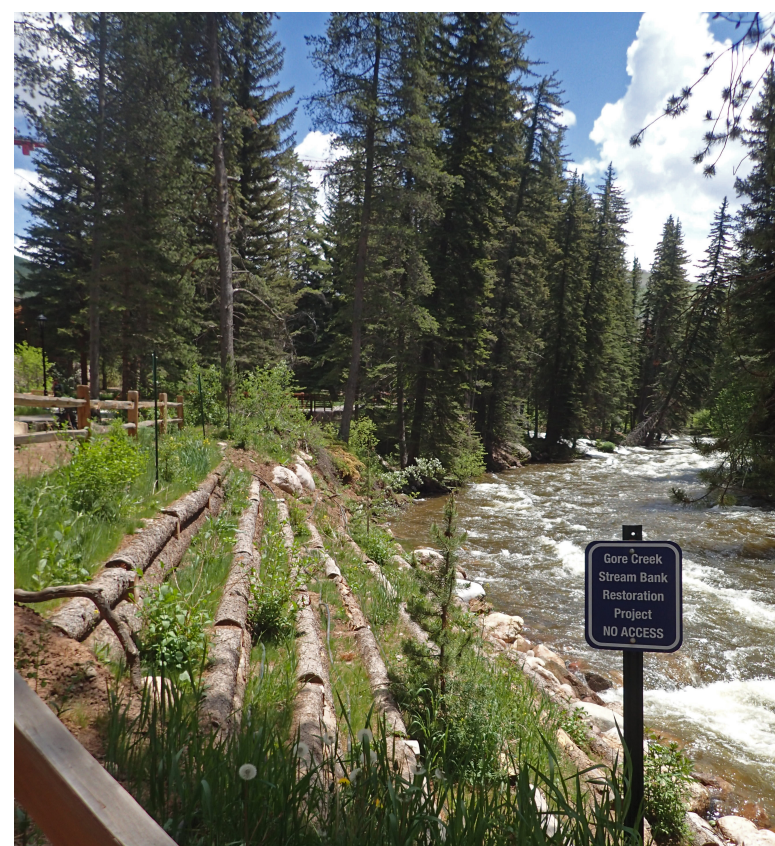
Flood erosion of a river bank completely scoured the Christopher Sewell pedestrian bridge abutment and the bridge was structurally unsound. The bank was rebuilt and trained in place and the abutment was stabilized in place to save the bridge and defer the more significant costs of replacing the bridge.

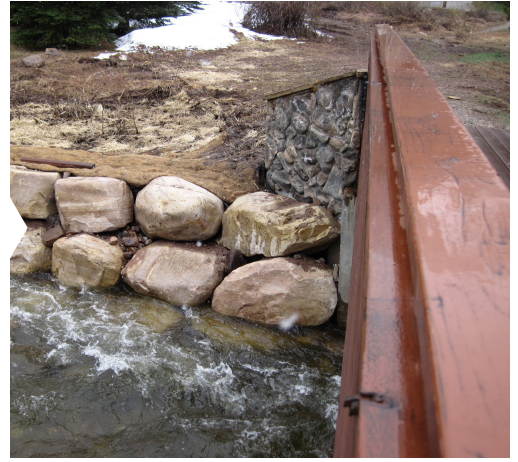
The south bank of Gore Creek near the Number 7 tee box after 100-year flooding threatened collapse of the adjacent bike path. The bank was rebuilt to provide ample buffer between the path and top of the bank. Live willow staking and ample riparian restoration were installed to help stabilize the bank.

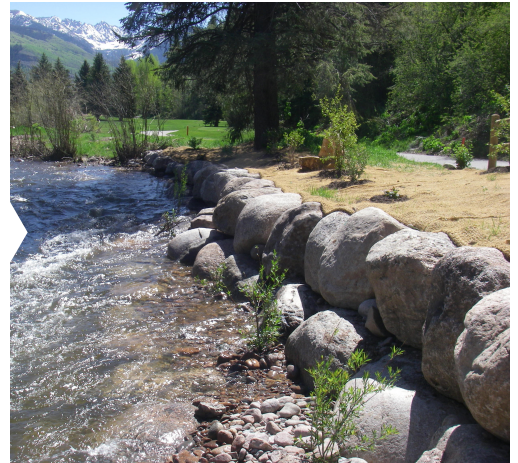
100-year flooding caused 50 lateral feet of channel migration and the collapse of Aspen Court bridge. RiverRestoration realigned the river and stabilized the bank with a combination of stone toe protection and a live crib bank. The live crib design allowed for the mass of channel deposits to be cost effectively disposed onsite into the rebuilt bank. The floodway conveyance was restored with this project. Dense riparian vegetation was planted in the face of the crib as well on the overbank. The channel was designed for the continued transport of cobble materials and to accommodate potential future channel migration.

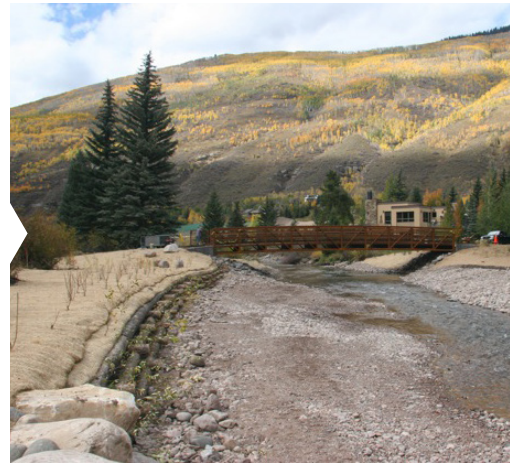
RiverRestoration worked with Terry Stone on a bike path realignment and crossing replacement over Middle Creek behind the Vail Public Library. The project also included an improved overlook and adjacent bio-stabilization (shown on previous page). This picture depicts the widened and improved trail and new bridge over Middle Creek. Significant channel stabilization was integral to the bridge design, but that stabilization blends in with the natural character of Middle Creek.
